WORKSHOP REPORT/DIAGNOSIS GUIDE

PT.STAR WAGEN INDONESIA

| Date: | 7 MARET 2023 | Customer Name: | PT. PUTRA PERKASA ABADI | Site: | PT MLP |
| Chassis No: | MFJ400243NJ001235 | Type : | 2528CX | Mileage / Hours Meter: | 4078/323 |

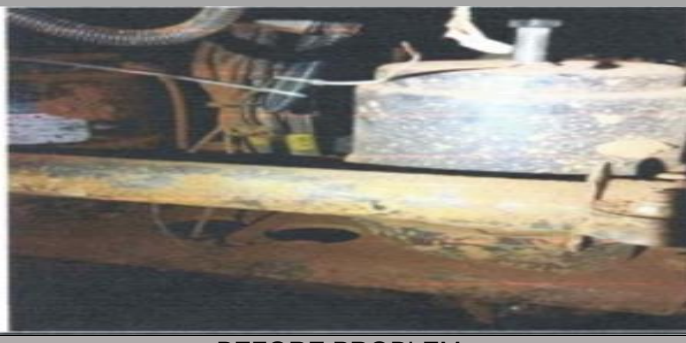
LAPORAN DARI OPERATOR UNIT DA25046, BAHWA UNIT MENGALAMI PROBLEM PADA INDIKATOR AIR PRESSURE YANG TIDAK MAU NAIK, SEHINGGA UNIT PADA BREAK SYSTEM TIDAK MAU RELEASE, SETELAH DILAKUKAN PENGECEKAN PADA UNIT, DITEMUKAN ADANYA KEBOCORAN PADA CHAMBER BREAK REAR AXEL 9,10 ACTION YANG DILAKUKAN MENGGANTI CYLINDER/CHAMBER ASSY

| PICTURE CAUSE AND ACTION | | | |
|---|---|---|---|
| BEFORE PROBLEM | AFTER PROBLEM | PROSES INSTALL | PROSES INSTALL |
