# Technical trouble

## Engine Noise

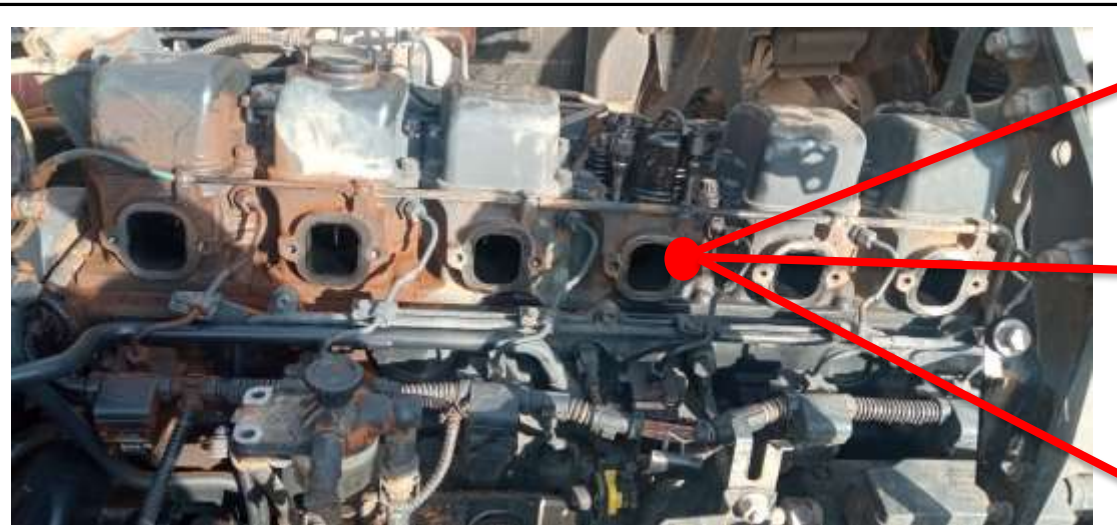
Dari hasil pemeriksaan stardi kemudian melakukan pengantian nozzle/injector silinder no.4 namun hasilnya engine masih noise, langkah selanjutnya melakukan penggantian unit pump PLD silinder no.4 yang sebelumnya harus melepas intake manifold terlebih dahulu, setelah intake manifold terlepas terlihat bahwa salah satu valve intake silinder no.4 patah

Pelepasan intake manifold

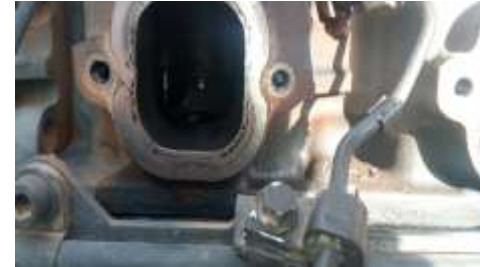
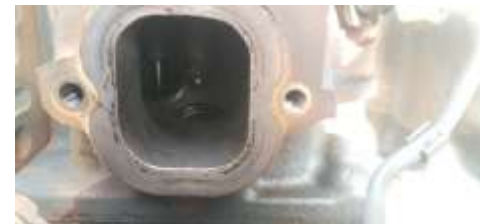
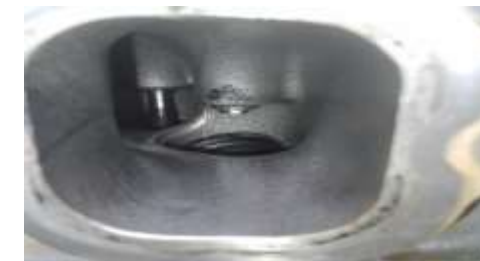
Salah satu valve intake patah dan terlihat patahan valve tidak jatuh ke dalam silinder namun menempel pada head silinder

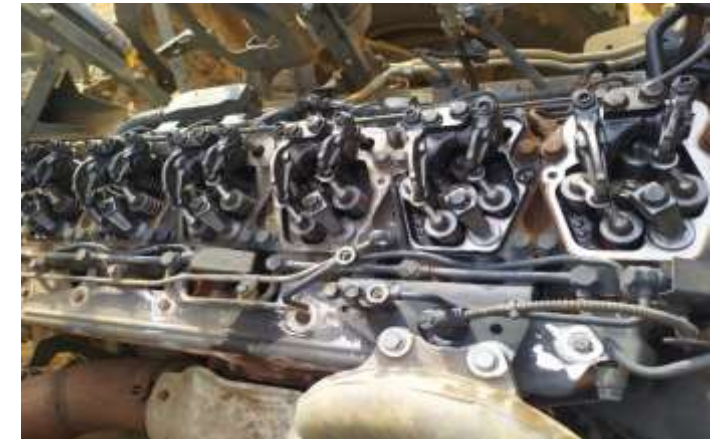
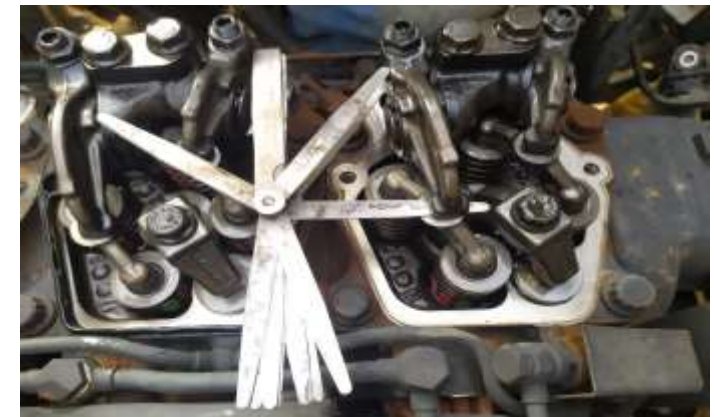
Valve clearance  
In 0.40 mm  
Ex 0.60 mm

Inspection tolerance ± 0.05 mm

Pengecekan valve clearance

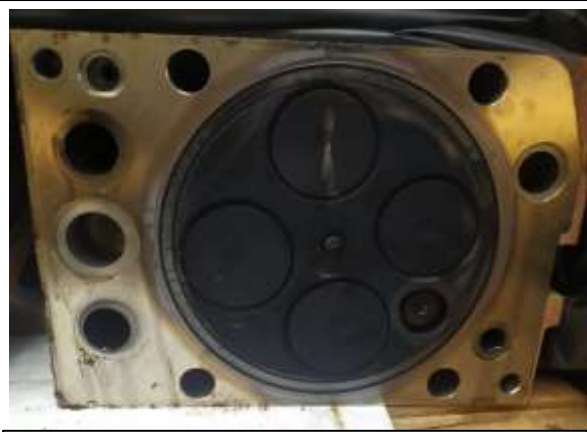
Head silinder no.1

Tampak head dan piston silinder no.1 tidak ada kerusakan apapun

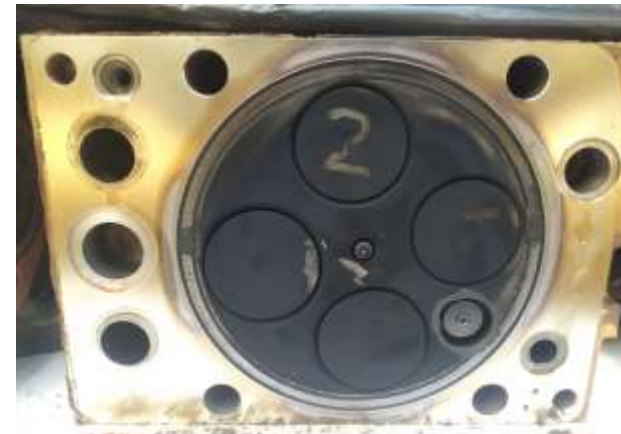
Head silinder no.2

Tampak head dan piston silinder no.2 tidak ada kerusakan apapun

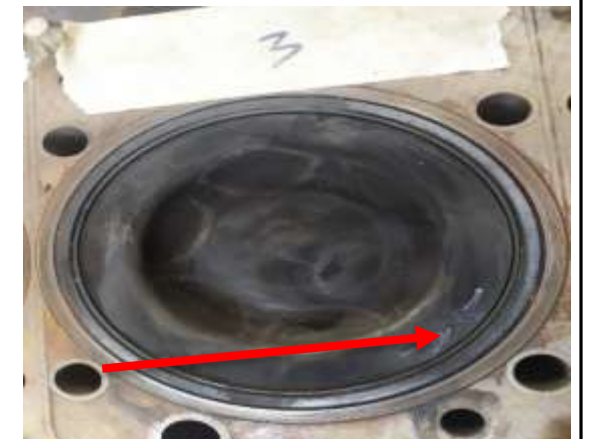
Piston silinder no.3

Pada piston silinder no.3 terdapat matrial kecil yang menempel pada permukaan

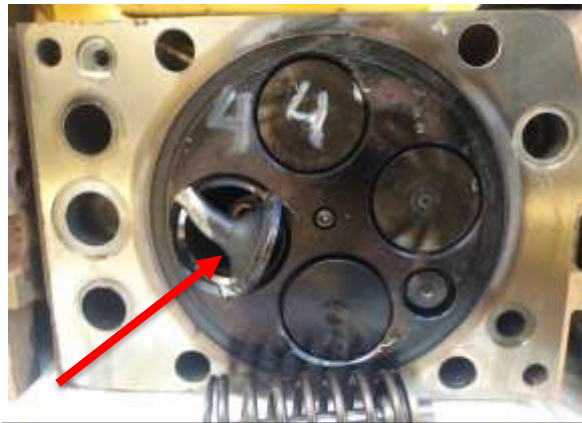
Head sislinder no.4

Patahan valve menempel pada head silinder dan piston mengalami kerusakan

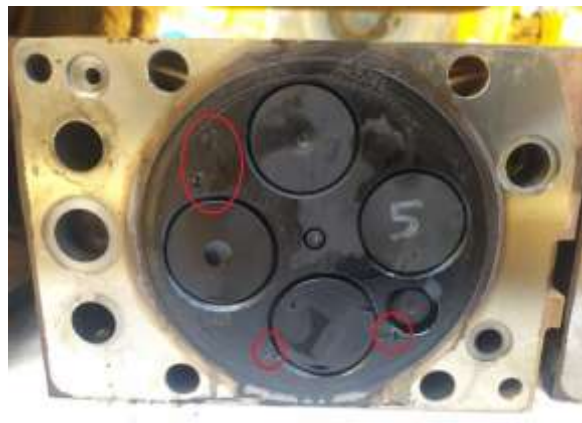
Head sislinder no.5

Terjadi kerusakan pada head silinder dan piston pada silinder no.5

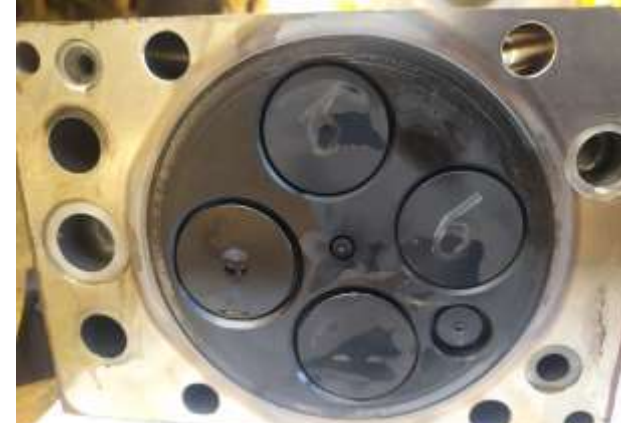
Head sislinder no.6

Tidak ada kerusakan pada head silinder namu terdapat matrial kecil dan kerusakan minor pada piston

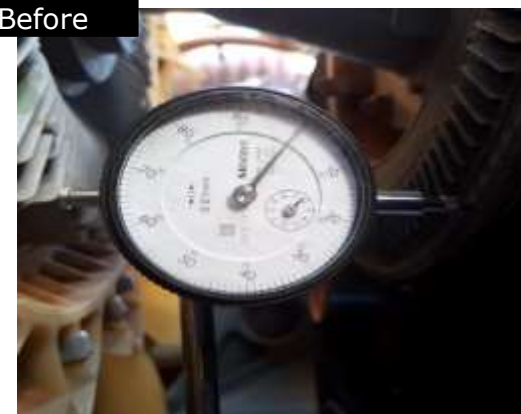
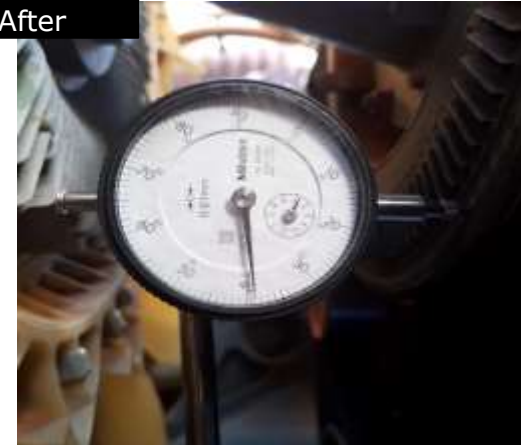
| Actual Measurement | <b>0.39 mm</b> |
| Kesimpulan /Conclusion | <b>Main bearing and crankshaft wornout</b> |

Pengukuran axial play crankshaft

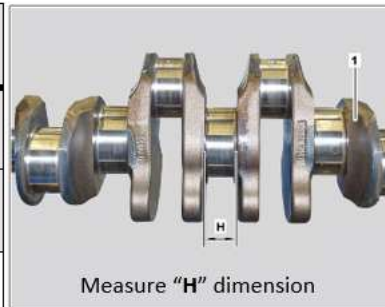
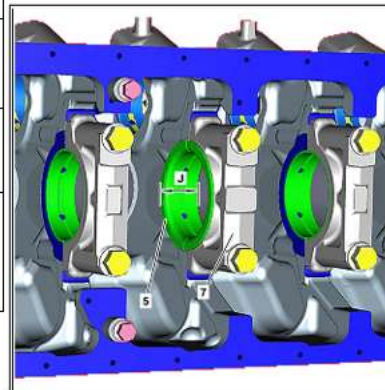
| Measurement Result | |
|---|---|
| Main Bearing Cap Condition | <b>WORNOUT</b> |
| Crankcase Condition | <b>WORNOUT</b> |

Hasil pengecekan main bearing crankshaft

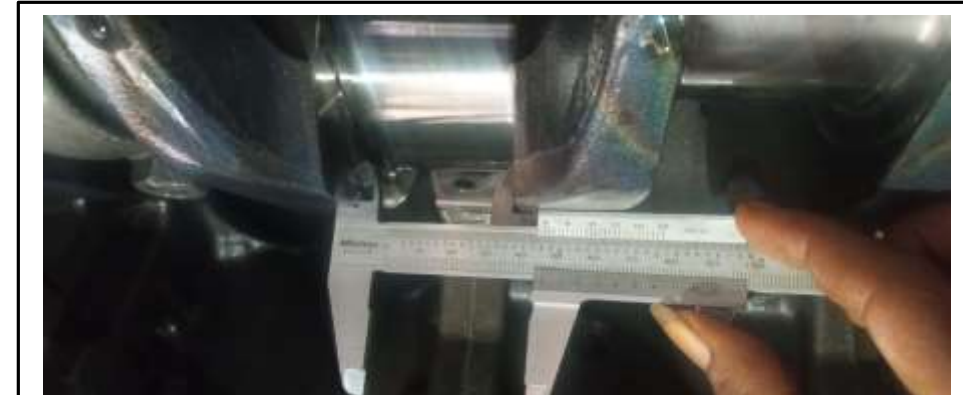
| Measurement Result | |
|---|---|
| Actual Measurement "H" | <b>46.48 mm</b> |

Pengukuran measurement "H"

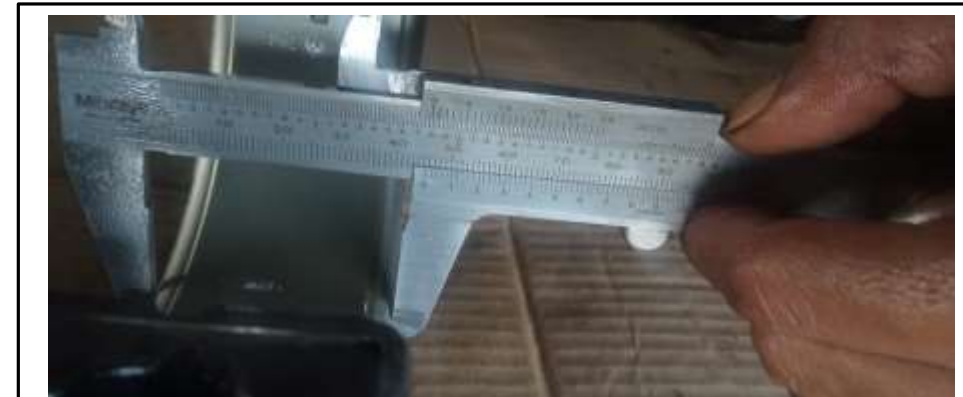
| Measurement Result | |
|---|---|
| Actual Measurement "J" | <b>45.52 mm</b> |

Pengukuran measurement "J"

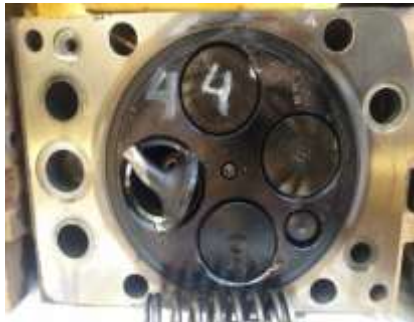
Head sislinder no.4

Berdasarkan hasil dari pengecekan dan pengukuran diatas ditemukan banyaknya part yang mengalami kerusakan seperti valve intake, silinder head, piston dan main bearing crankshaft

Dari seluruh hasil observasi dan pemeriksaan kemungkinan penyebab patahnya valve intake silinder no.4 besarnya clearance valve dan axial play pada crankshaft yang melebihi specification yang telah ditentukan. Rekomendasi penggantian part head silinder dan piston atau long block
