# PUTRA PERKASA ABADI

040 / PLT-MIP / CWR / 2023

## WARRANTY/POLICY CLAIM FORM

MODEL UNIT : AROCS 4040K (6X4) A/T

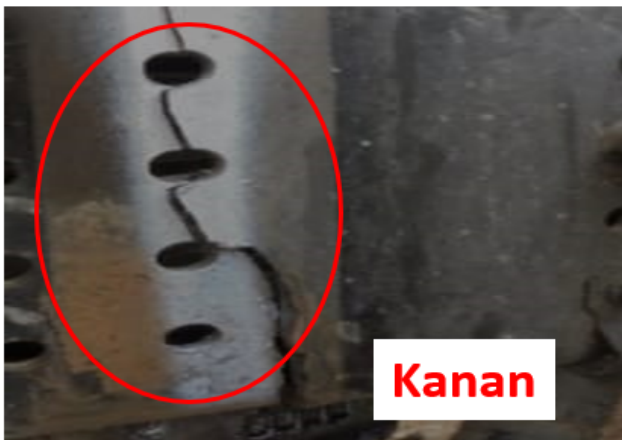
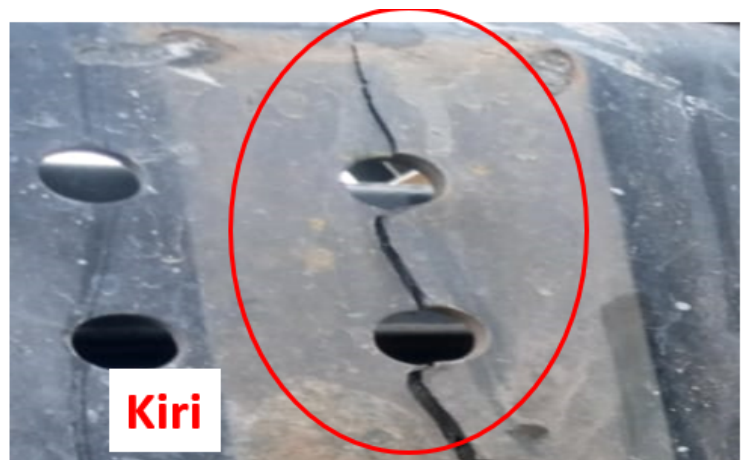
**FOTO KOMPONEN YANG RUSAK**

Chasis Crack front RH & LH
