## FAILURE ANALYSIS REPORT

| AXOR HDT | AXOR 2528 C EURO 2 | MERCEDES-BENZ | 27-Dec-24 | 27-Dec-24 |
| FT2519 | PPA-BIB | | | 5910 HM / 47916.7 KM |

Pada tanggal 27 Desember 2024, customer melaporkan bahwa unit FT2519 mengalami problem yaitu REAR AXLE HOUSING CRACK. Mekanik melakukan pengecekan dan meminta data untuk pengajuan warranty ke DCVI.

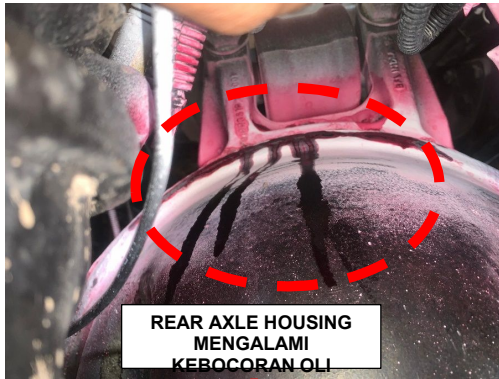
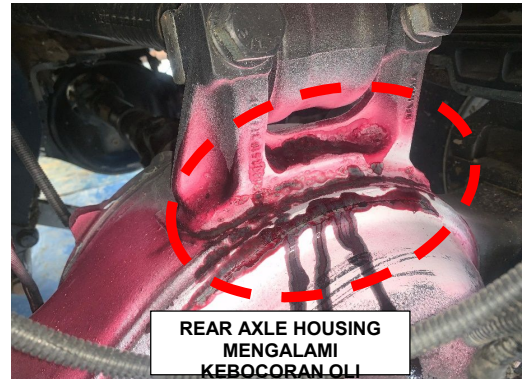
SETELAH UNIT DILAKUKAN WASHING PADA  
AREA REAR AXLE HOUSING LALU UNIT  
GROUNDTES SEJAUH 500M, REAR AXLE  
HOUSING MENGALAMI KEBOCORAN  
OLINYA

| ANALYSIS |
|---|
| Dari data yang dikumpulkan, penyebab terjadinya rear axle housing crack di unit FT2519 adalah karena daya tahan pada pengelasan rear axle housing mengalami penurunan. Lalu, faktor yang menyebabkan daya tahan axle housing mengalami penurunan adalah housing terbentur dengan material luar, terjadinya reaksi kimia dengan lingkungan yang menyebabkan korosi pada housing rear axle dan terkelupasnya cat pada rear axle housing mengakibatkan korosi. |

| DATA SPAREPARTS RECOMMENDED | | | |
|---|---|---|---|
| 1 | A4003504130 | LU AXLE HOUSING COMPL / ABS | 1 |

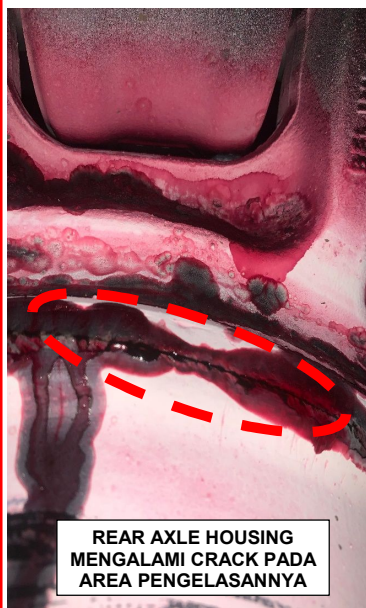
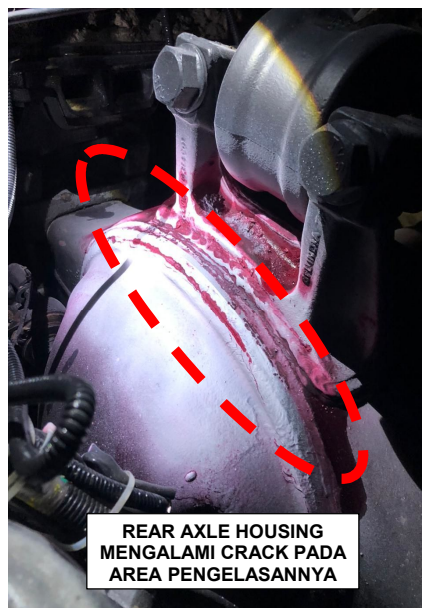
MEKANIK MELAKUKAN  
INSPEKSI, TERJADINYA  
CRACK DI AREA  
PENGELASAN REAR AXLE  
HOUSINGNYA
