CUSTOMER NAME	PT. PUTRA PERKASA ABADI	PHONE NO. / HP		
KOTA / BRANCH	SITE AMI, CENTRAL BORNEO		DATE	31-Mar-24

UNIT TYPE	COMP MODEL	BRAND	INSTALL DATE	PROBLEM DATE
AXOR HDT	AXOR 2528 CX EURO 4	MERCEDES-BENZ	25-Jan-23	27-Mar-24

DETAIL PROBLEM

On February 27, 2024, The operator DA25058 notifies the mechanic that the transmission is abnormal

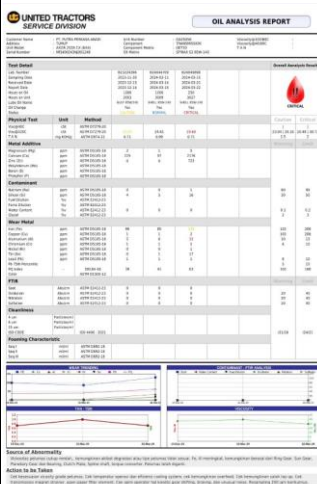
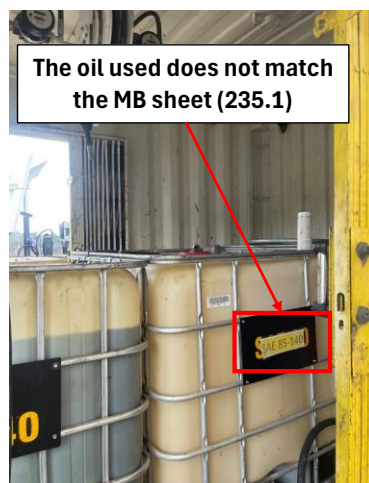
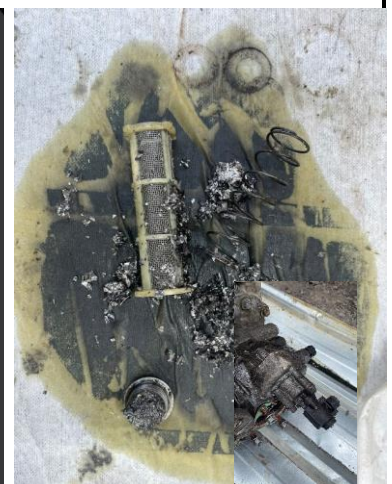
HISTORY UNIT

*kamis/ NIGHT SHIFT/ 14.03.2024

CODE UNIT	: DT25058
HM READY	: 3027
ARRIVAL	:
START	: 15.00
FINISH	: 21.00
MTC CODE	: Uns
STATUS	: Ready
LOCATION	: Ws Haju

MAIN PROBLEM :

- Fill Plug T/M missing

COMPONENT :

- T/M

ACTION :

- Flaxing Oil T/M 2 kali
- Cleaning Strainer T/M
- Fill oil T/M
- Final Check

NOTE:

Plug fill Oil T/M swap from DT25036 to DT25058

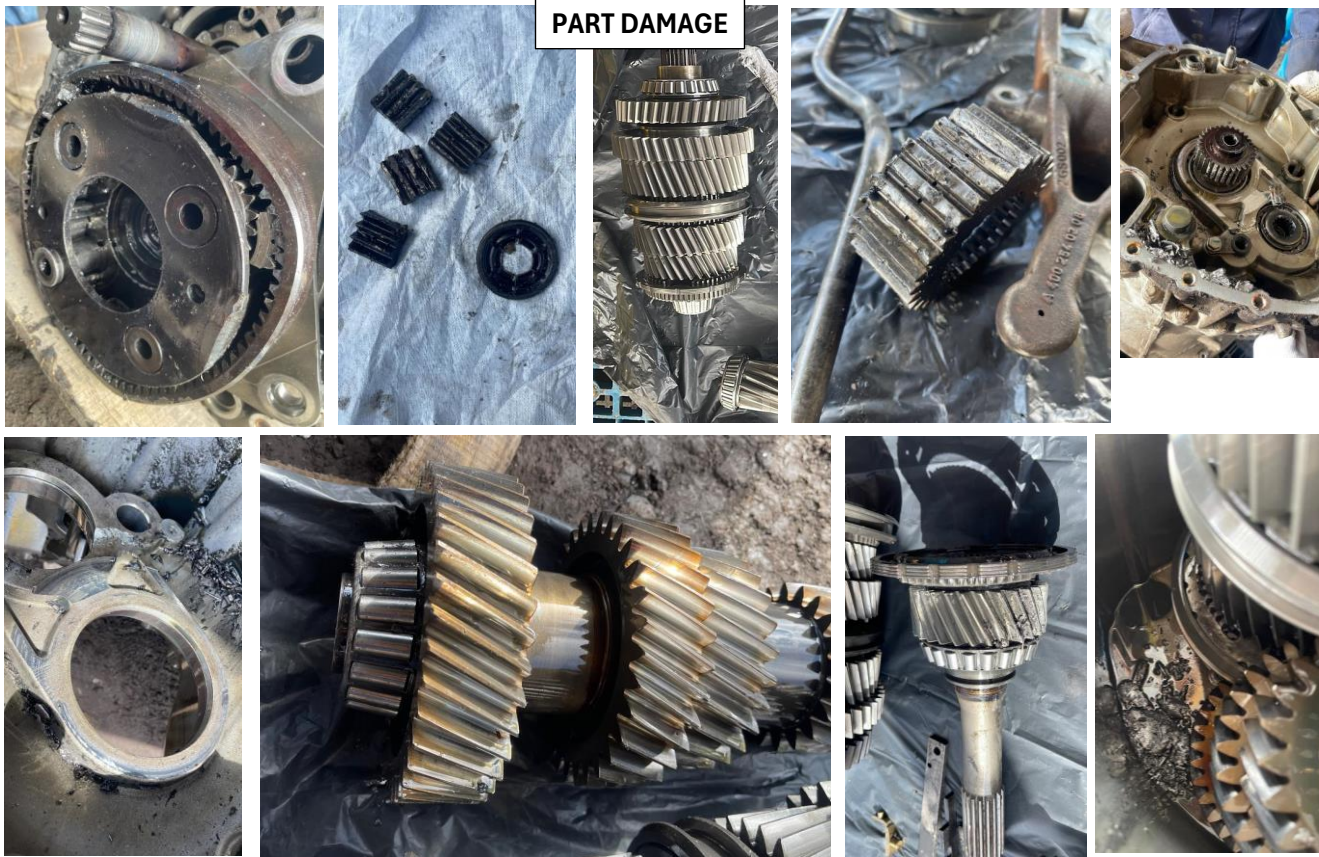
PHOTO

After inspection and collect data, we found the inner part damage, Because lubrication is not optimal, besides that there is a maintenance history where the fill plug is lost, This condition is very likely to cause damage to the inner part, can also be seen from the results of PAP, in addition, the oil used does not comply with MB sheet (235.1).
