WORKSHOP REPORT/DIAGNOSIS GUIDE

PT.STAR WAGEN INDONESIA

| Date: | 7 MARET 2023 | Customer Name: | PT. PUTRA PERKASA ABADI | Site: | PT MLP |
| Chassis No: | MFJ400243NJ001235 | Type : | 2528CX | Mileage / Hours Meter: | 4078/323 |

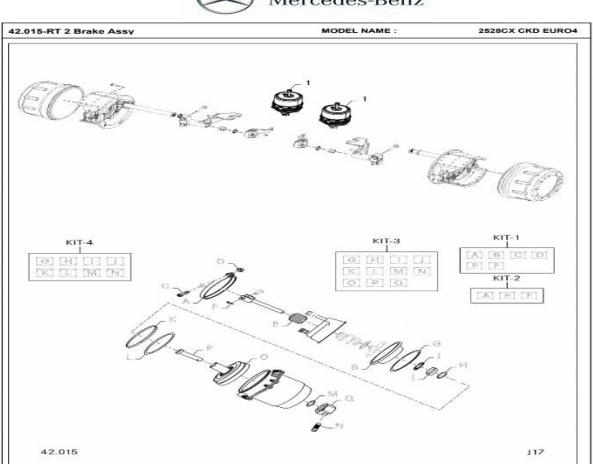
| PICTURE CAUSE AND ACTION | | | |
|---|---|---|---|
| Part Book | picture part no aktual | picture part no part new | PROSES INSTALL |

LAPORAN DARI OPERATOR UNIT DA25046, BAHWA UNIT MENGALAMI PROBLEM PADA INDIKATOR AIR PRESSURE YANG TIDAK MAU NAIK, SEHINGGA UNIT PADA BREAK SYSTEM TIDAK MAU RELEASE, SETELAH DILAKUKAN PENGECEKAN PADA UNIT, DITEMUKAN ADANYA KEBOCORAN PADA CHAMBER BREAK REAR AXEL 9,10 ACTION YANG DILAKUKAN MENGGANTI CYLINDER/CHAMBER ASSY
