# Technical trouble

## Engine Noise

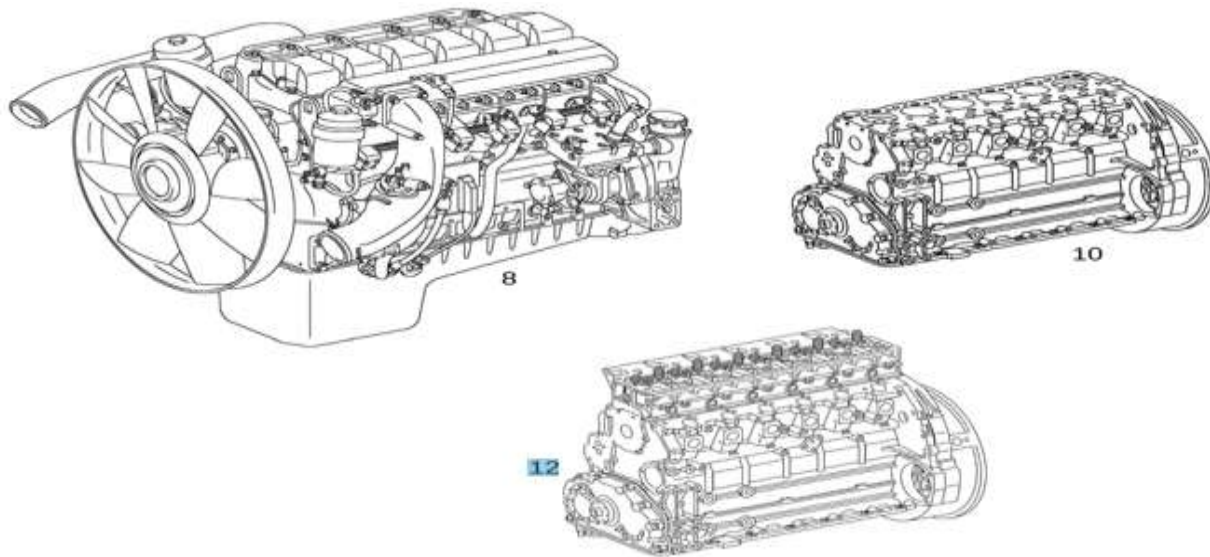
12 A 460 010 11 50

Dari seluruh hasil observasi dan pemeriksaan kemungkinan penyebab patahnya valve intake silinder no.4 besarnya clearance valve dan axial play pada crankshaft yang melebihi specification yang telah ditentukan. Rekomendasi penggantian part head silinder dan piston atau long block

PARTIAL ENGINE
