## FAILURE ANALYSIS REPORT

| AXOR HDT | AXOR 2528 CH Euro 4 | MERCEDES-BENZ | 29-Jul-23 | 20-Nov-25 |
| DA25136 | PPA-AMI | | 8060h/96663km | |

Ketika melakukan service ditemukan gram upnormal pada plug engine

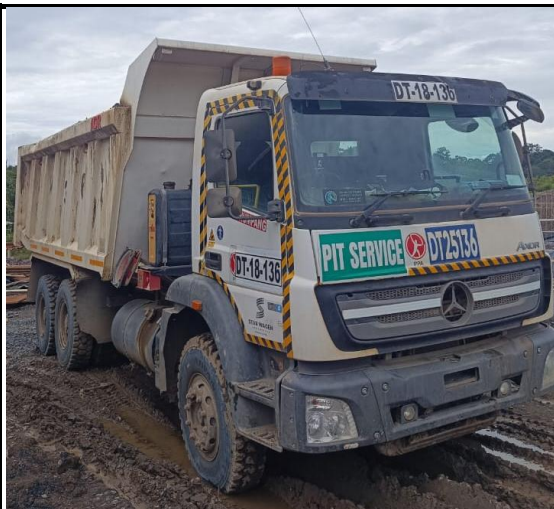
### PHOTO

| ANALYSIS |
|---|
| Dari data yang dikumpulkan setelah melakukan pelepasan pada drain plug ketika service ditemukan gram upnormal pada plug, kemudian mekanik check historical pernah melakukan penggantian PLD no 4, lalu diliat dari hasil PAP terdapat temuan kandungan iron dan cooper yang tinggi, selesai melakukan pengecekan hasil PAP kemudian mekanik melakukan check di PLD no 4 ditemukan bending dan Camshaft Damage, setelah itu mekanik melakukan check by xentry terdapat data bahwa ada temuan engine overspeed |

| ANALYSIS |
|---|
| Dari hasil investigasi dimana unit pernah mengalami overspeed karena kesalahan operator bukan dari kesalahan product atau principle Mercedes Benz, maka status warranty REJECTED |

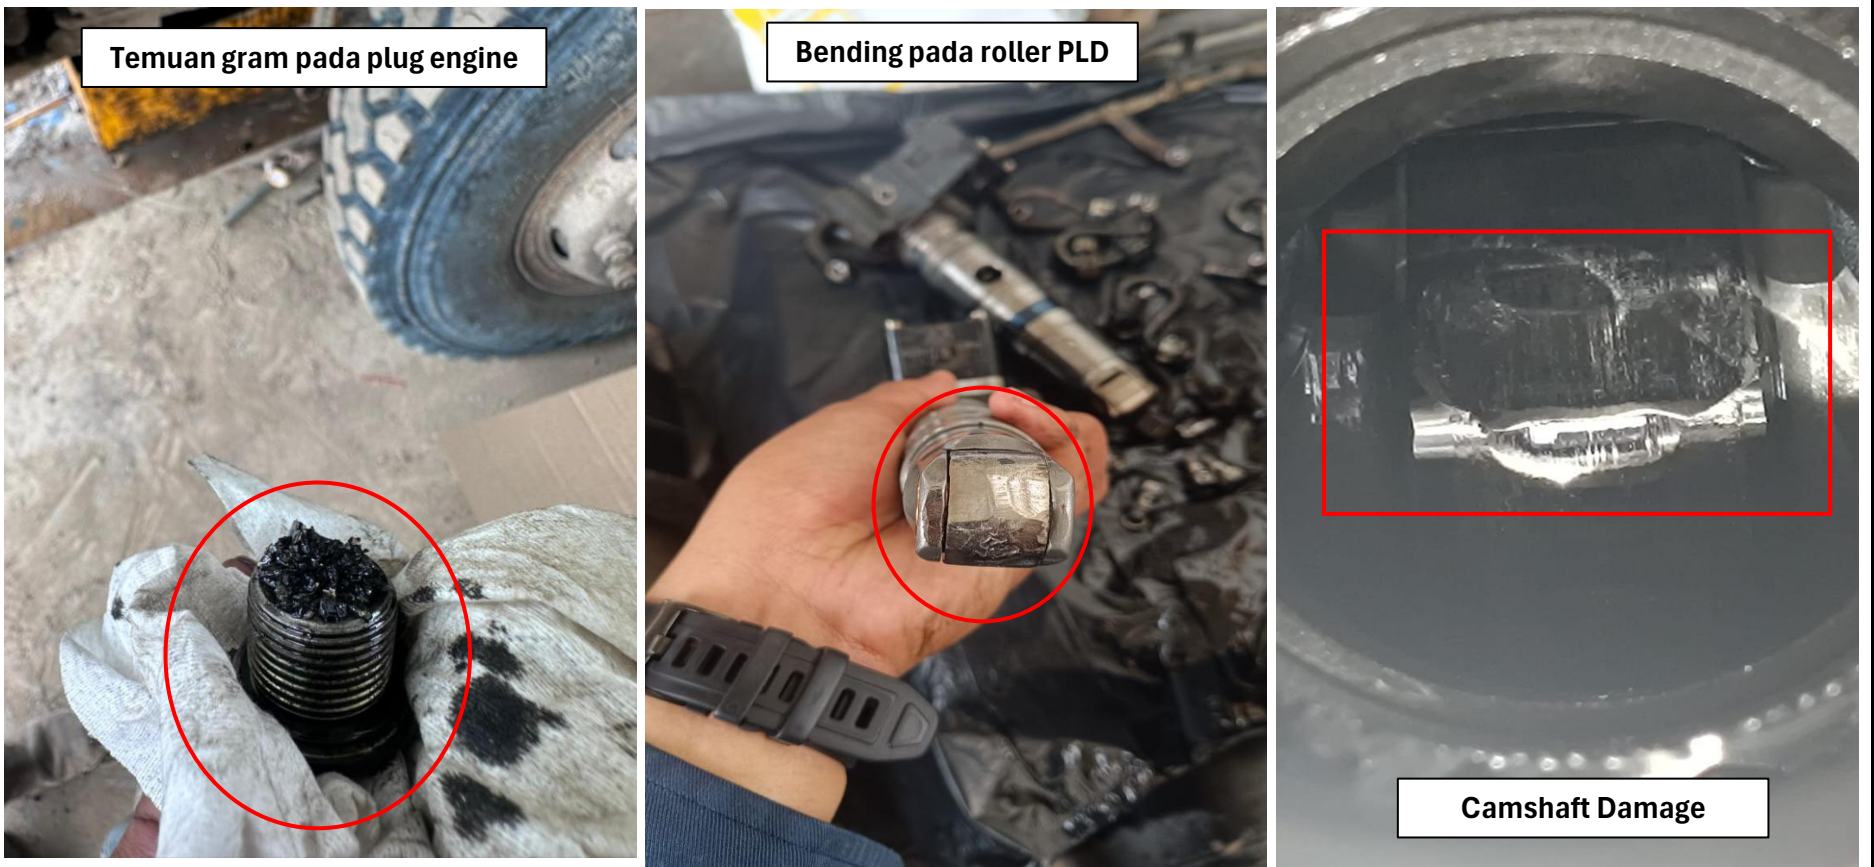
Kandungan cooper dan iron tinggi
